CASE STUDY 3 Weld failure investigation

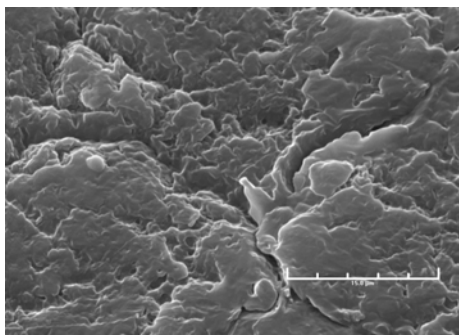
Supplier A surface

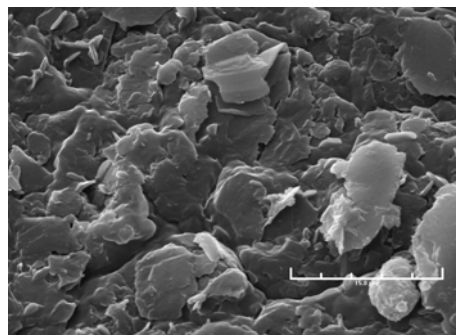
The samples were visually inspected using first an optical microscope and then a scanning electron microscope. It was immediately apparent that the topographical nature of the two materials was different as shown below. Energy dispersive X-ray analysis (EDX) was used to elementally compare the two surfaces and significant differences were found. Material from supplier A being more rich in chlorine and material from supplier B also showing evidence of relatively high concentrations of magnesium, silicon and oxygen.

Supplier B surface

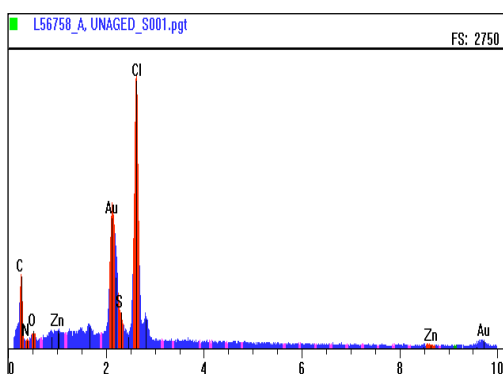
Supplier A EDX analysis

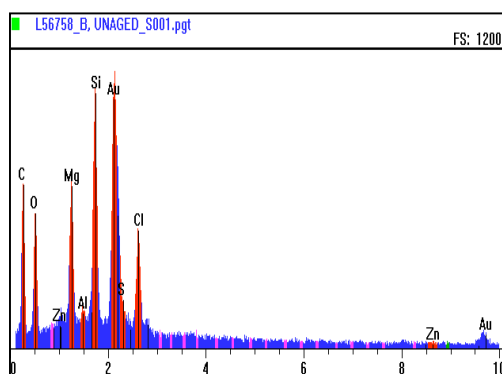
Supplier B EDX analysis

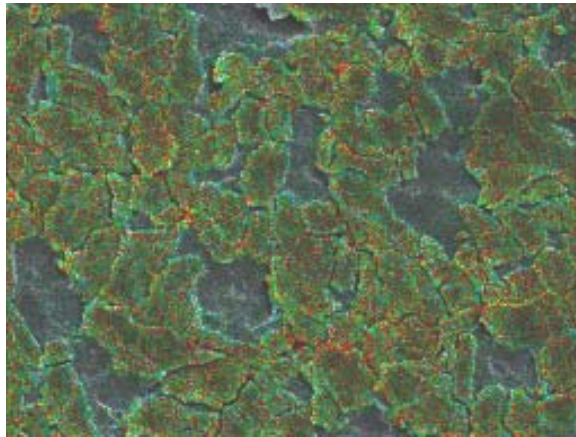
FTIR analysis of the surface suggested a good match with internal standards for Talc and an elemental map was used to confirm that this was in the region of the platy deposits seen on the SEM.

Elemental map of talc deposits on surface

It was concluded that in the case of supplier B residual talc deposits were forming a mechanical barrier to chlorination of the surface and preventing adequate adhesion. The supplier changed his process and weld strength results came into line with those from supplier A. Since supplier B was a lower cost supplier this was eventually selected as a preferred supplier.
