CASE STUDY 4 – Chemical analysis

Product fault investigation

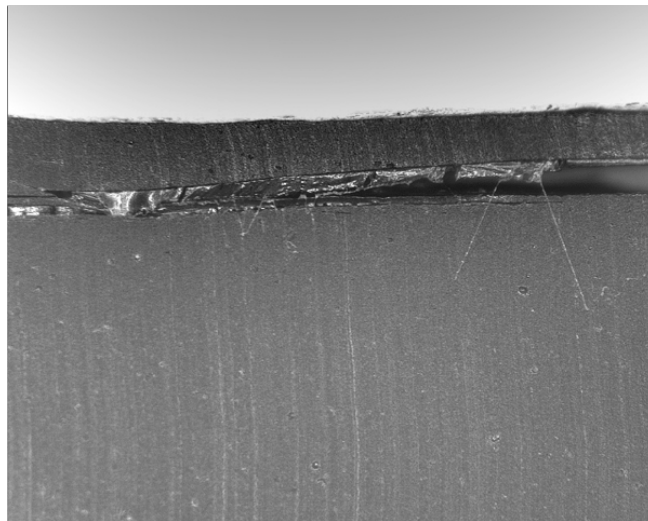
Optical examination revealed the presence of thin layers of soft, transparent plastic material on the blister faces, as illustrated below.

Cross-section through blister, optical image, x20

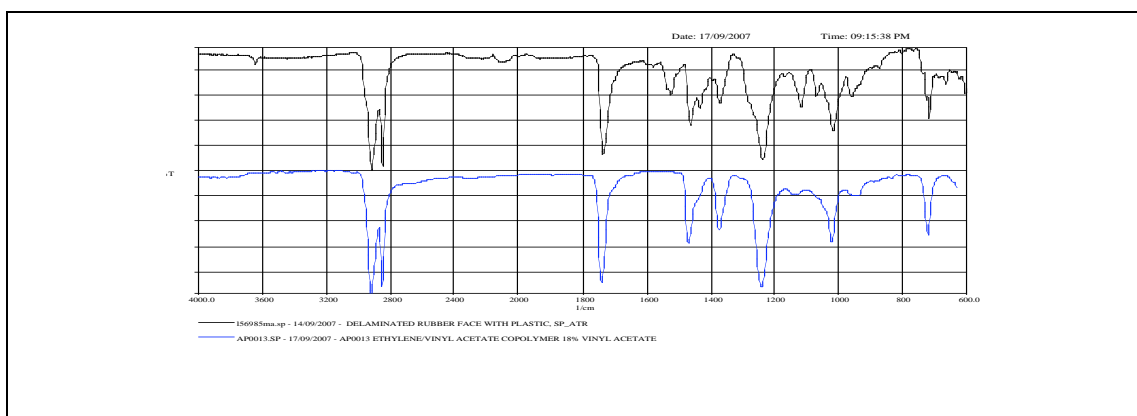
IR spectra of EVA and suspect material

Though not an exact match the spectra strongly suggests the presence of EVA on the blister surfaces (with a relatively low vinyl acetate content, in the region of 18% providing the best spectra match). A survey of the customer mixing facility showed that a key ingredient was bought in with an EVA protective wrap, which should have been removed prior to mixing and this was matched to the IR spectra.

EVA protective wrap on a key compound ingredient was identified as the root cause of the moulding problem. Actions were put in place by the customer to ensure that all this material was removed prior to mixing.
